Dräger Medical, Inc.

JULIAN
TECHNICAL SERVICE BULLETIN # 200

Product: Julian

Re: **Replacement of pressure absorption PCB on the EDOS block**

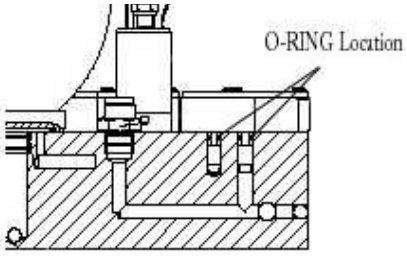
Reason/Rational: To ensure no leaks in the EDOS block after replacement of pressure absorption PCB (8201761)

Figure. 1 shows location of o-rings on the pressure sensor ports internal to the EDOS block. Figure. 2 shows the where the o-rings are located on the pressure absorption PCB from the top.

Solution/Procedure: Install o-ring (8410713) on to pressure sensor input / output ports on pressure absorption PCB when replacing in the field. See diagrams below for location of o-rings.

Additional Info: New pressure absorption PCB's do not have the associated o-ring with it, it is recommended that four (4) o-rings be ordered with each pcb or the old o-rings are transferred to the new PCB pressure sensors.
